# **FLOOD PLAIN MANAGEMENT**

**A Study Of Upper North River**

**Augusta County, Virginia**

**September 1984**

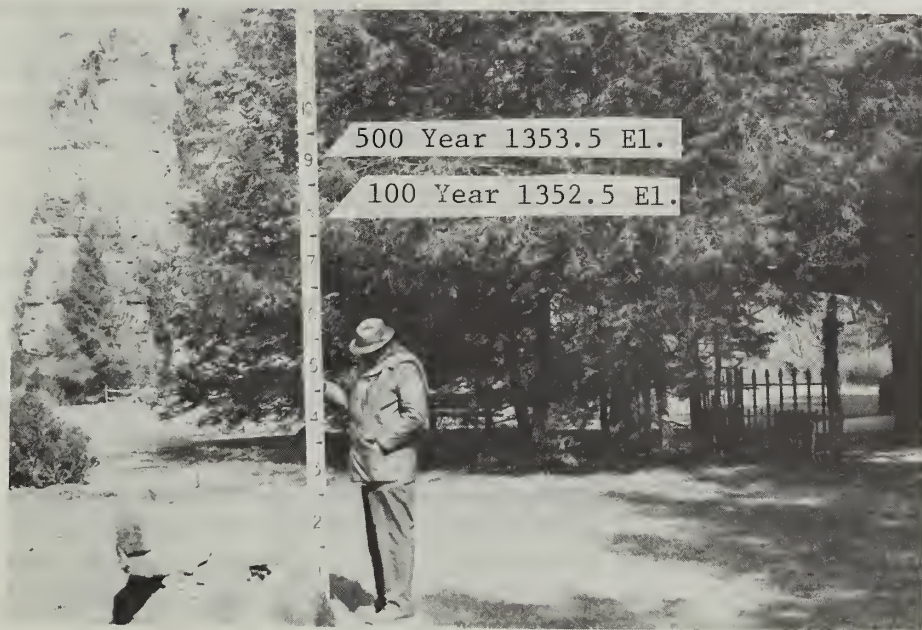
Figure 2. Approximately 200 feet south of Natural Chimneys at base of Sun Dial.

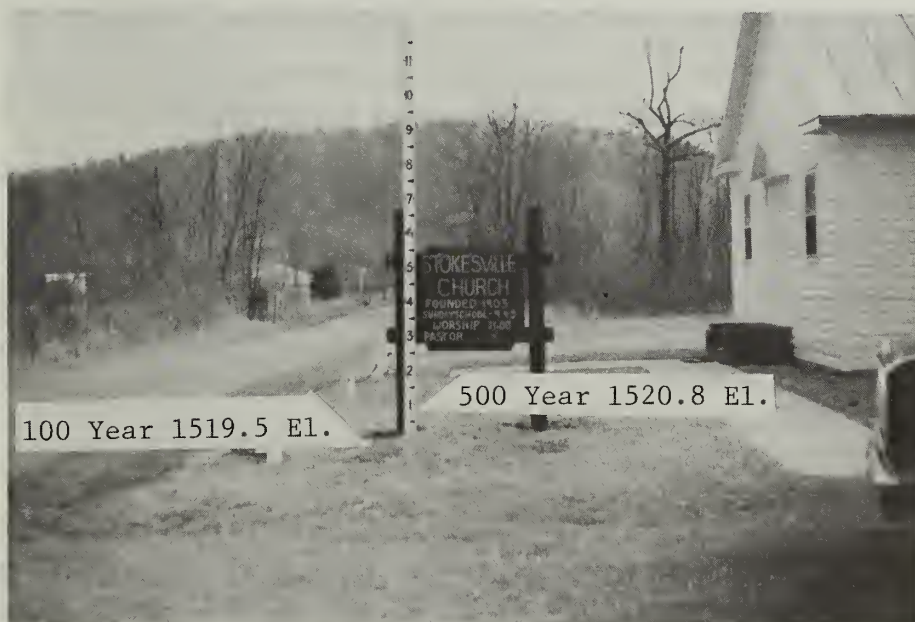
Figure 3. Looking north across state route 730 approximately 700 feet below the junction of State routes 730 and 718 at Stokesville.

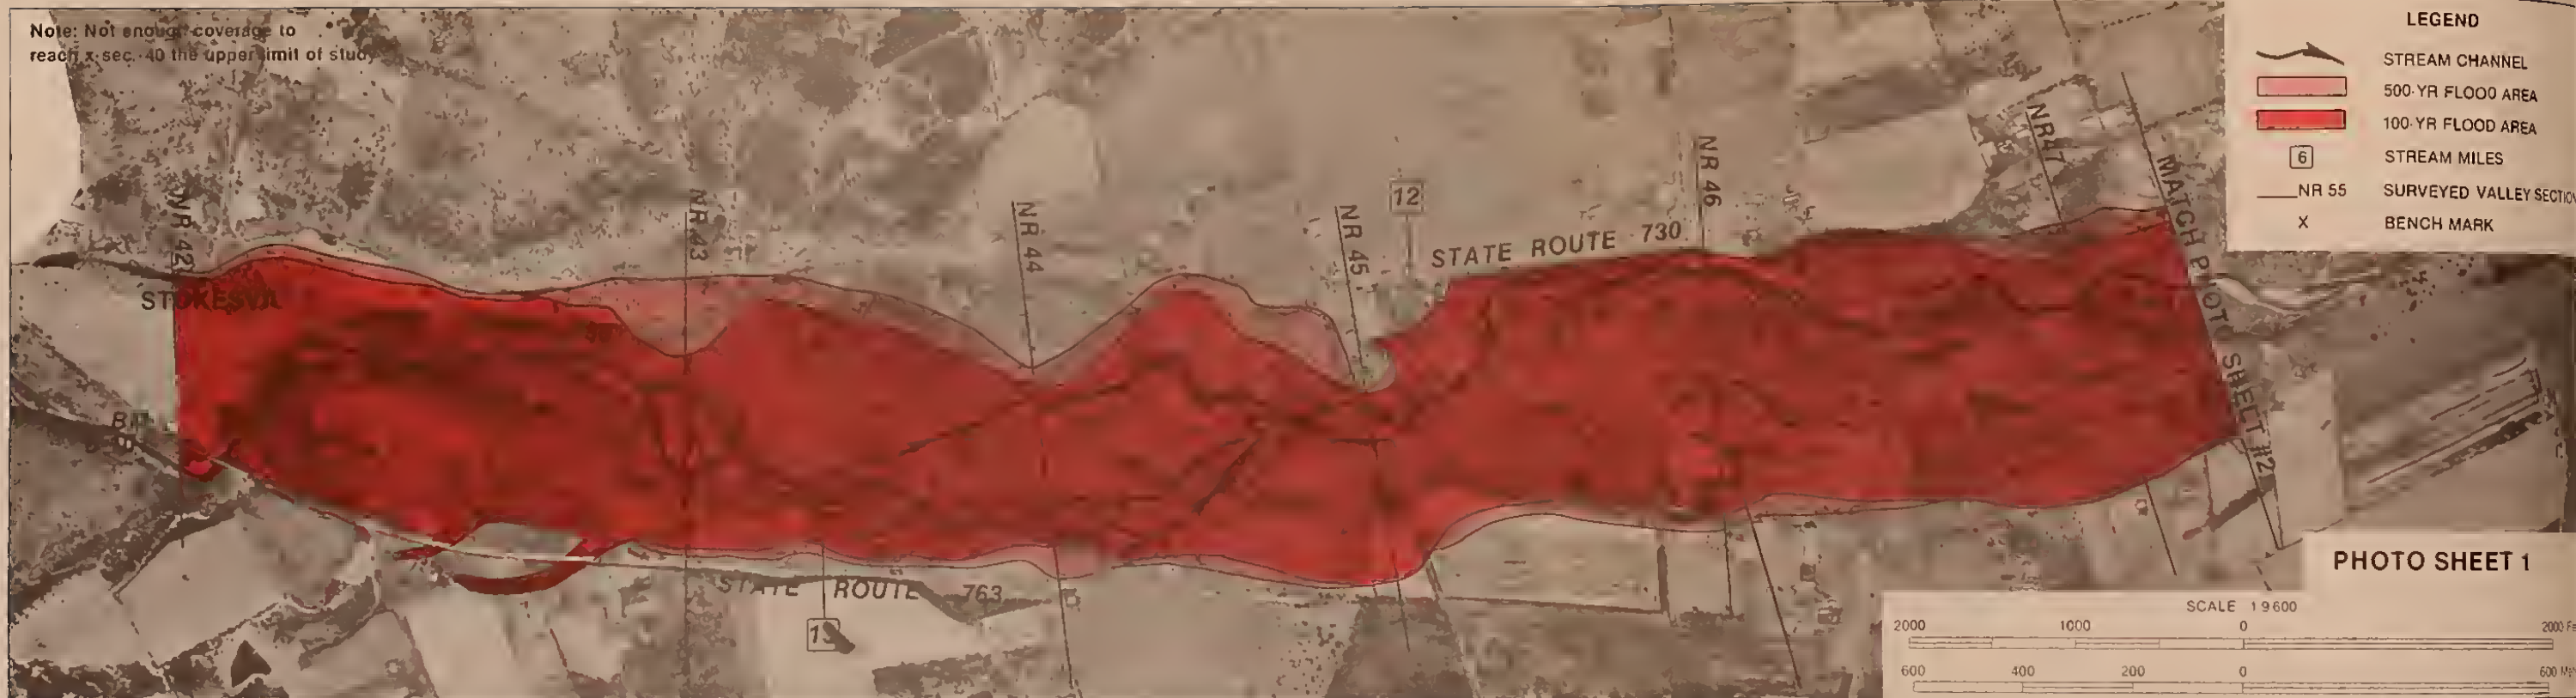
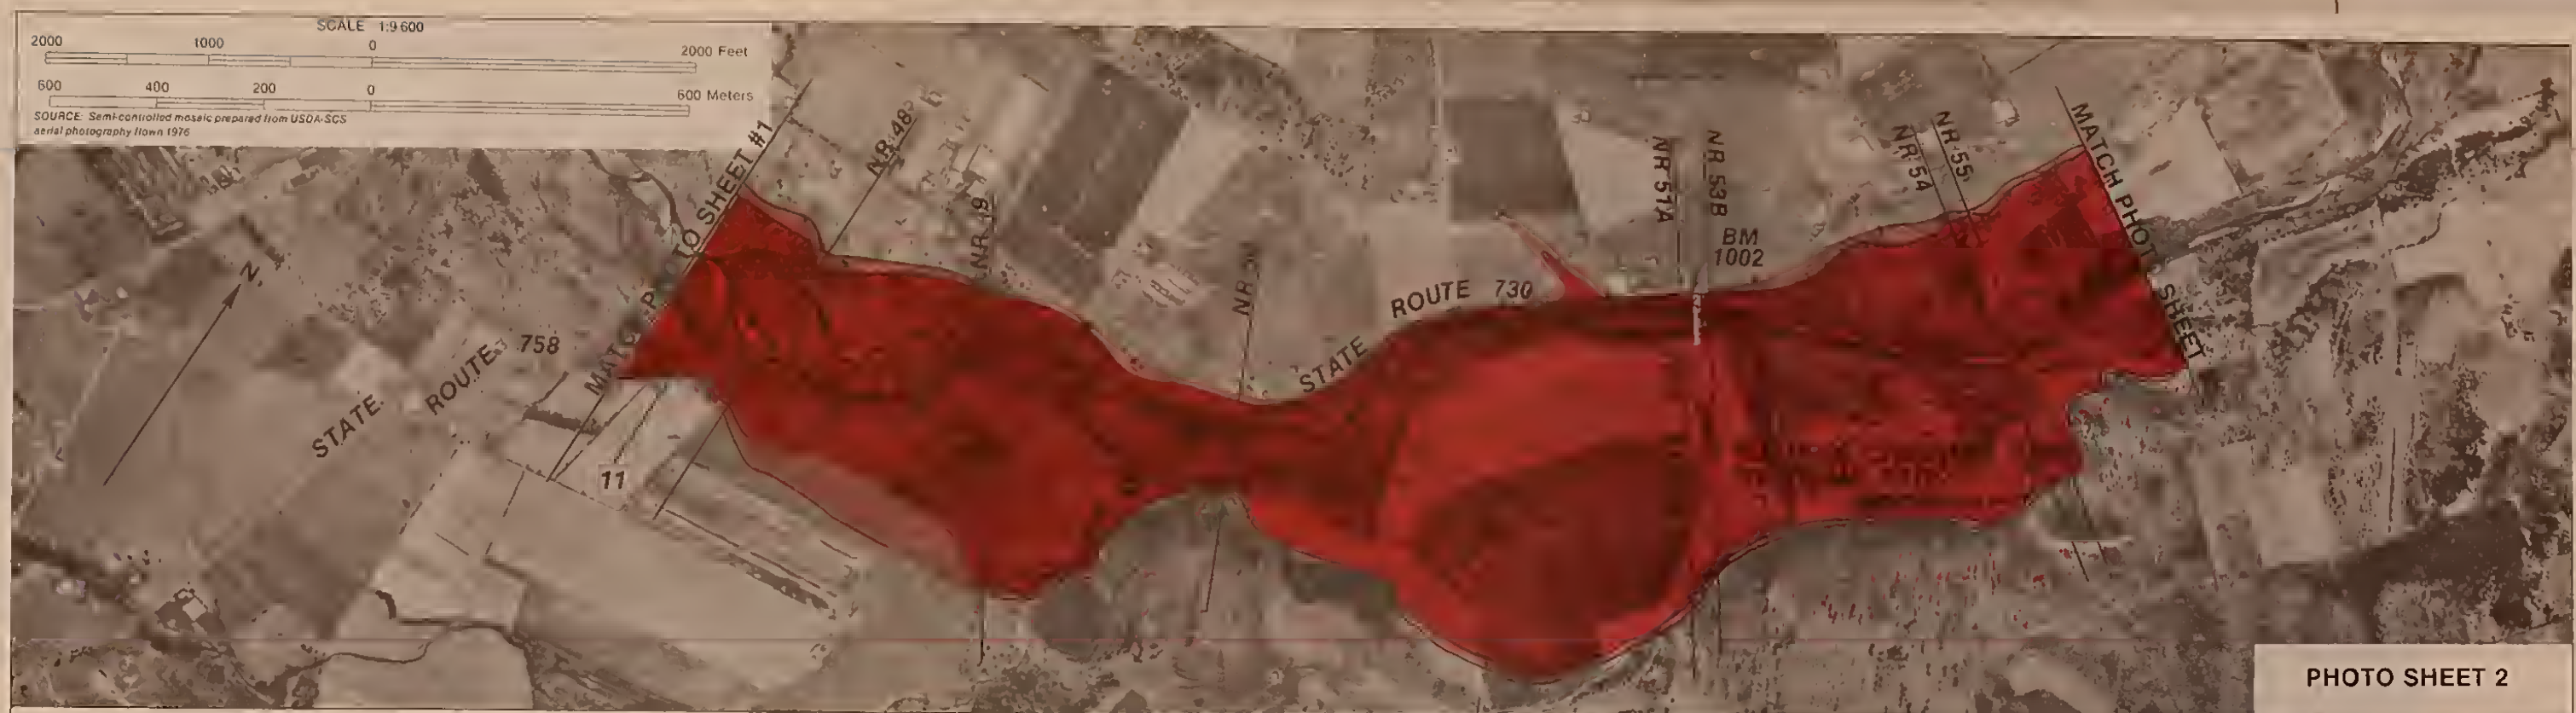
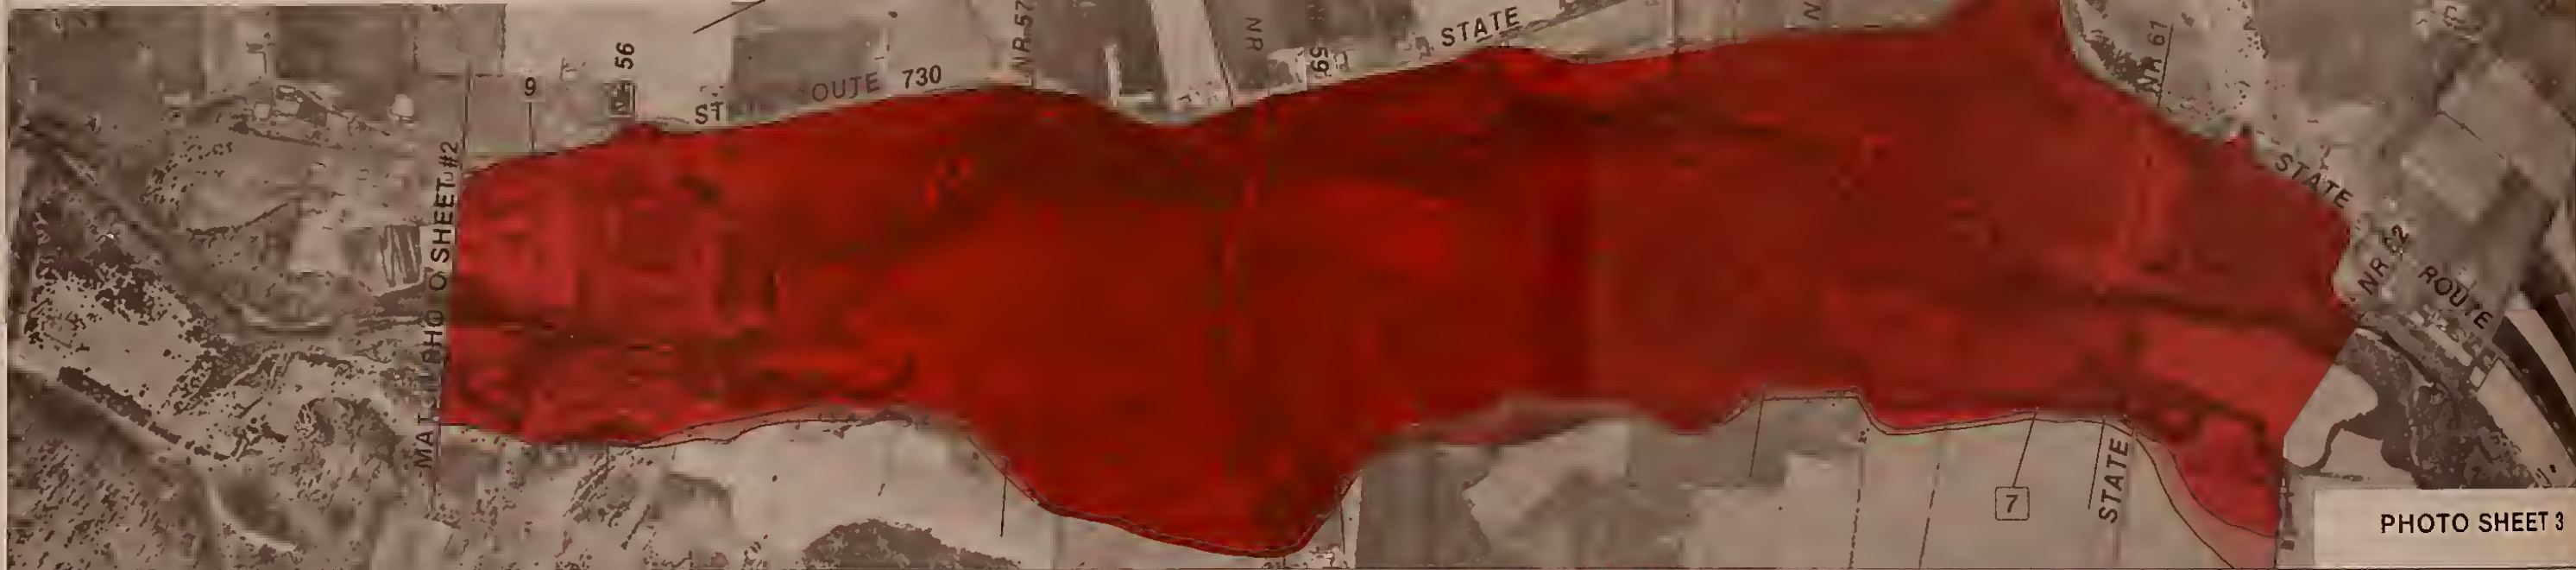
PHOTO SHEET 1

Flood plain photomaps show the area covered by the 100-and 500-year floods. Where only one line is shown, there is no difference in the boundary of the two flood areas. These photomaps should be used to determine approximate flood elevations.

The Flood Plain Area Photomaps can be used for decisions where precise elevations are not required; for example, a brief check of the appropriate photomap may indicate that a proposed building site is obviously in or out of the flood plain.
